DEPARTMENT OF TRANSPORTATION

Office of Structural Materials

Contract #: 04-0120F4Cty: SF/ALA Rte: 80 PM: 13.2/13.9File #: 69.28**WELDING INSPECTION REPORT****Resident Engineer:** Pursell, Gary**Address:** 333 Burma Road**City:** Oakland, CA 94607**Report No:** WIR-012554**Date Inspected:** 18-Feb-2010**Project Name:** SAS Superstructure**OSM Arrival Time:** 700**Prime Contractor:** American Bridge/Fluor Enterprises, a JV**OSM Departure Time:** 1900**Contractor:** Zhenhua Port Machinery Company, Ltd (ZPMC), Changxing Island **Location:** Shanghai, China**CWI Name:** Du Zhi Qun**CWI Present:** Yes No**Inspected CWI report:** Yes No N/A**Rod Oven in Use:** Yes No N/A**Electrode to specification:** Yes No N/A**Weld Procedures Followed:** Yes No N/A**Qualified Welders:** Yes No N/A**Verified Joint Fit-up:** Yes No N/A**Approved Drawings:** Yes No N/A**Approved WPS:** Yes No N/A**Delayed / Cancelled:** Yes No N/A**Bridge No:** 34-0006**Component:** Tower**Summary of Items Observed:**

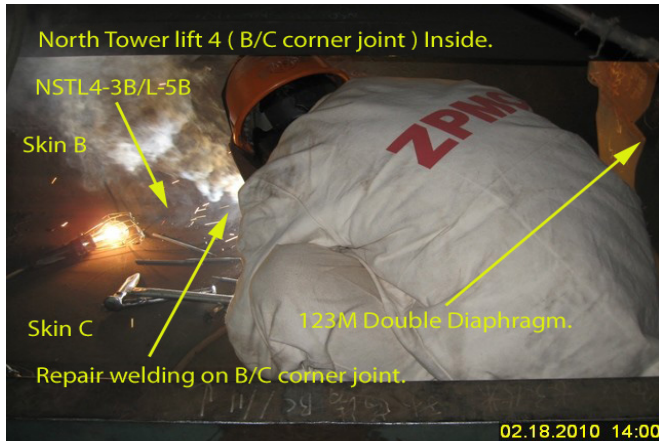
This QA Inspector observed ZPMC qualified welding personnel identified as 057258, Perform Shielded Metal Arc Welding (SMAW) on North Tower lift 4 B/C corner joint. The weld identified as NSTL4-3B/L-5B, near 123M double Diaphragm. ZPMC QC Identified as Sun Tian Liang, with Temporary welding repair report. The welding parameters as measured using QC's calibrated instrument appeared to be in general compliance with WPS-345-SMAW-2G (2F) - Repair. For more information see attached photos.

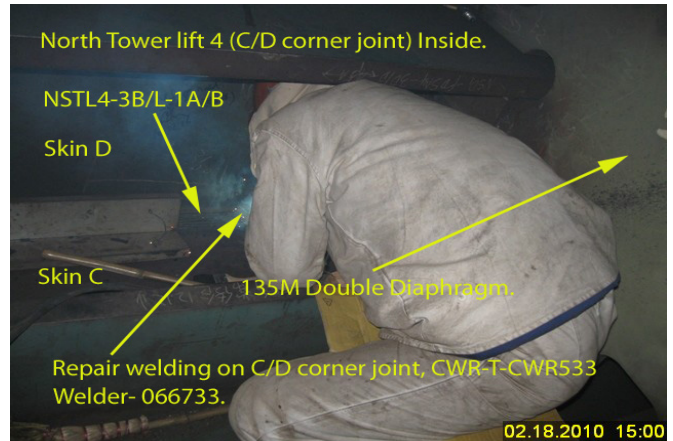
This QA Inspector observed ZPMC qualified welding personnel identified as 066733 Perform Flux Core Arc Welding (FCAW) on North Tower lift 4 C/D corner joint. The weld identified as NSTL4-3B/L-1A/B, Y location is 10600 to 10900mm. ZPMC CWI Identified as Du Zhi Qun, with Critical welding repair report, CWR -T-CWR533. The welding parameters as measured using QC's calibrated instrument appeared to be in general compliance with

WPS-345-FCAW-1G (1F) - Repair. For more information see attached photos.

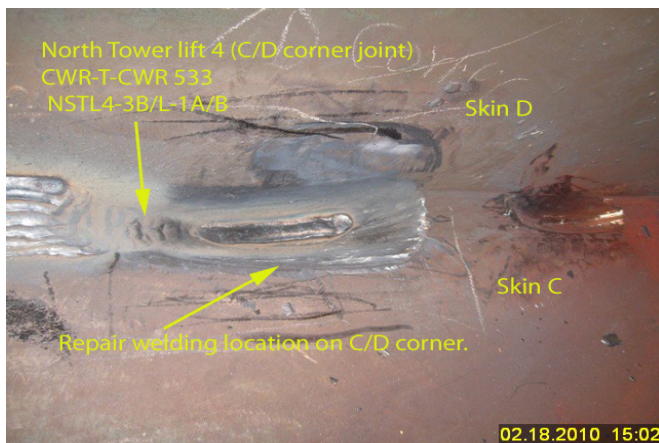
This QA Inspector observed ZPMC qualified welding personnel identified as 066236 Perform Shielded Metal Arc Welding (SMAW) on North Tower lift 4 C/D corner joint. The weld identified as NSTL4-3B/L-1A/B, Y location is 13040mm. ZPMC CWI Identified as Du Zhi Qun, with Critical welding repair report, CWR –T-CWR533. The welding parameters as measured using QC's calibrated instrument appeared to be in general compliance with WPS-345-SMAW-1G (1F) - Repair.

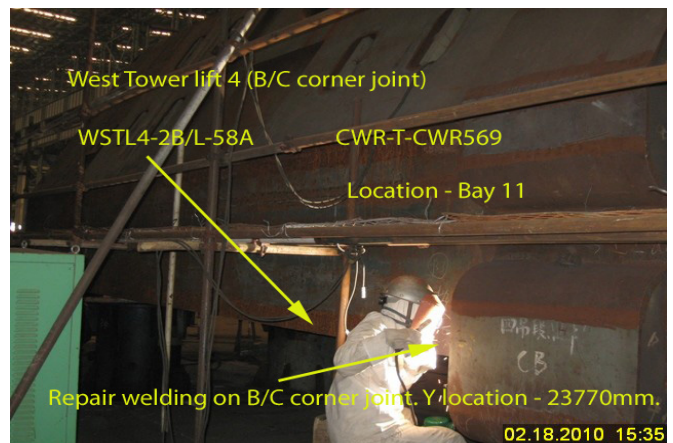
This QA Inspector observed ZPMC qualified welding personnel identified as 066361, Perform Shielded Metal Arc Welding (SMAW) on West Tower lift 4 B/C corner joint. The weld identified as WSTL4-2B/L-58B, Y location is 23770mm. ZPMC CWI Identified as Lilin, with Critical welding repair report, CWR –T-CWR569. The welding parameters as measured using QC's calibrated instrument appeared to be in general compliance with WPS-345-SMAW-2G (2F) – Repair. For more information see attached photos.
